LAKE TANGLEWOOD SOUTH DAM

LAKE TANGLEWOOD NORTH DAM

CAPE GIRARDEAU COUNTY, MISSOURI

**PHASE 1 INSPECTION REPORT
NATIONAL DAM SAFETY PROGRAM**

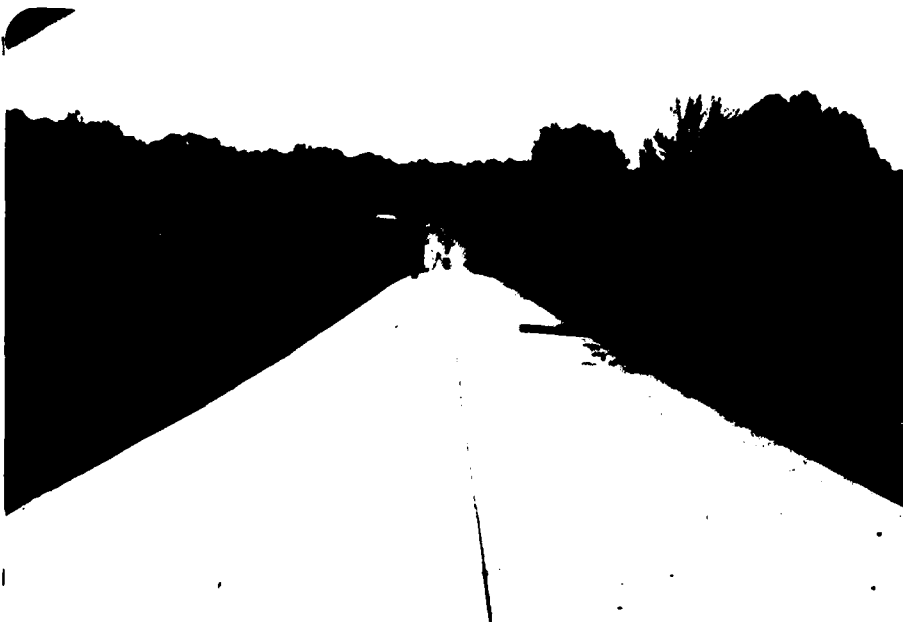
- (a) South Dam. The crest serves as a roadway with a 20-foot width of concrete pavement. The remainder of the crest is sparsely vegetated with grass and weeds. The crest is slightly higher (0.5 ft. \pm) in the center of the dam than at the abutments. No cracks, slumps, or abnormal deformations were noted on the crest. Photo 5 shows the crest of the dam.

PHOTO NO. 5 - CREST OF DAM TAKEN FROM RIGHT END
